# Evaluation of Composite and Standard Liner Plates on Hydraulic Face Shovels Operating in Platinum Mines

The article details the results of research determining whether the use of composite liner plates, specifically chromium-carbide overlay (CCO) liner plates could be recommended as an alternative to abrasion-resistant (AR) plates to extend the production cycle of hydraulic face shovels operating in platinum mines.

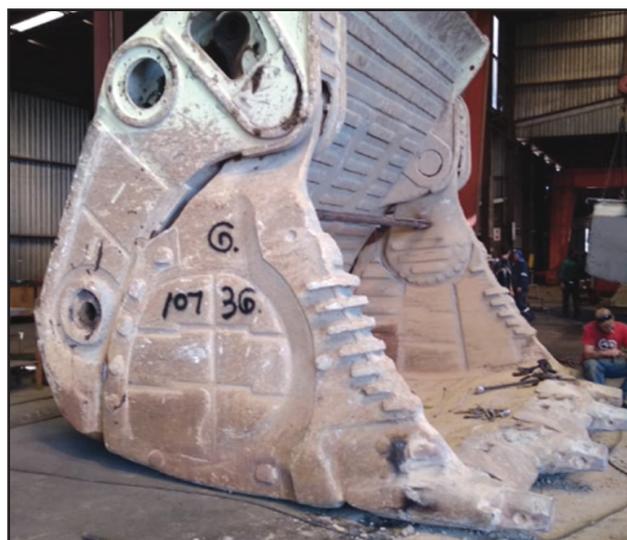
Figure 1 illustrates a component marked for repair and relining after completing its production cycle in a platinum

mine, having been removed from production due to excessive wear (Borox Wear Parts (Pty) Ltd, 2020).

**FIGURE 1:** RH340 3G component (JCB-Gearvest (Pty) Ltd, 2018)

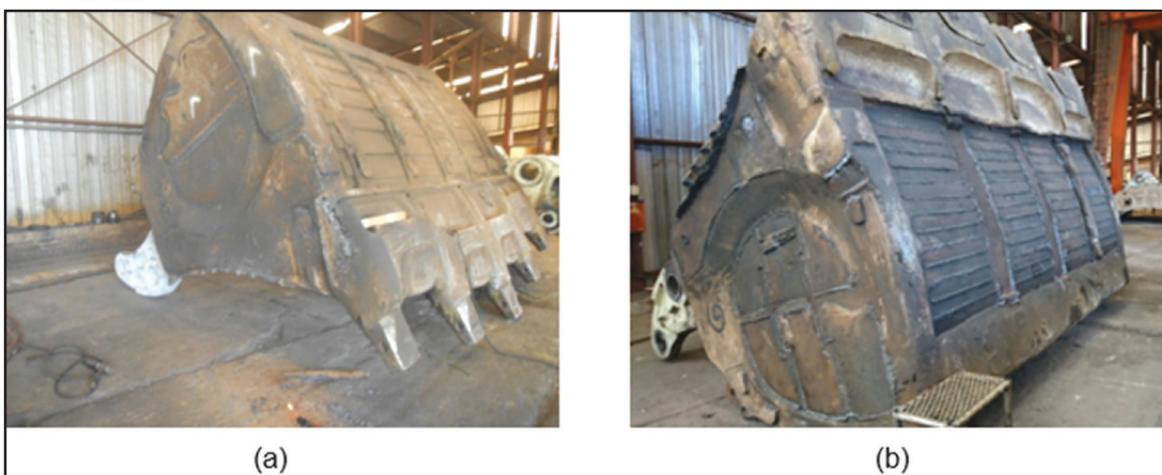
Figure 3, illustrates the components during the gouging process, where the old wear package is removed, and the components are prepared for the fitment of the new wear packages. This also shows the extent of the wear sustained by the component during production.

Where the wear packages have been excessively worn, the structure of the component, especially on the sidewalls, has been exposed. The structure of a component is significantly more expensive and time consuming to repair.

FIGURE 3: Stripping and gouging components before repair: (a) Component relined with AR-Plates (b) Component relined with CCO (JCB-Gearvest (Pty) Ltd, 2018)

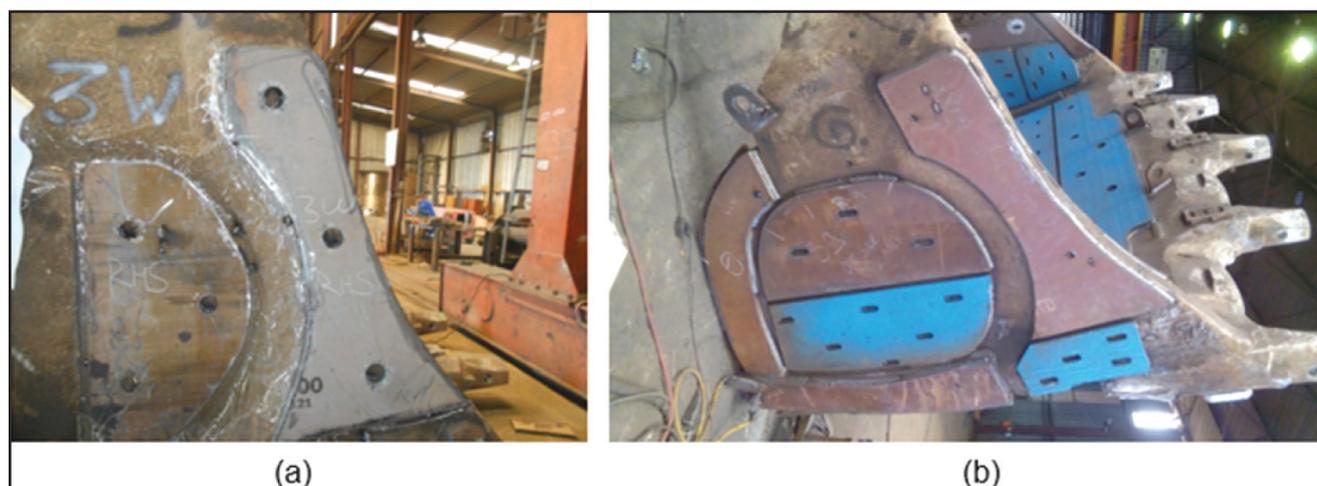
Figure 4 shows the fitment process of the respective wear packages onto the components. The CCO liner plates are marked in blue and are unique to the component.

FIGURE 4: Fitment of wear packages (a) AR-plates wear package (b) CCO wear package (JCB-Gearvest (Pty) Ltd, 2018)

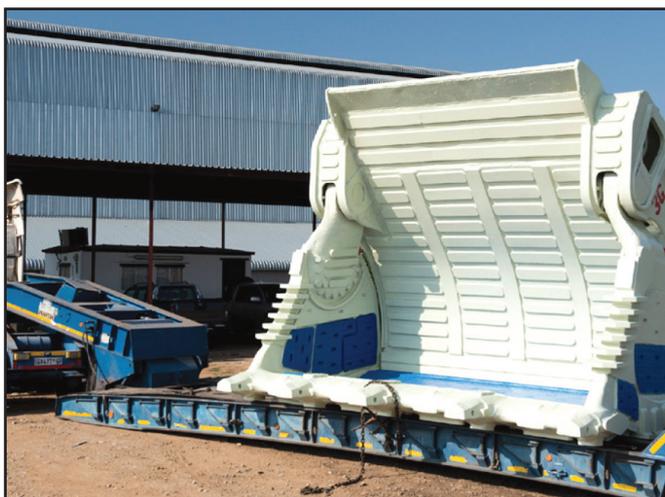
In typical scenarios, this does not present a problem, but because the CCO liner plate specifications deviated from the standard composite liner plate overlay ratios, the mild steel base became too thin to adequately weld the parts onto the structure of the face shovel without the overlay deposit contaminating the welding consumables. The recommended welding consumables, i.e. 307 stainless steel welding consumables, must be used to weld the CCO parts. Figure 5 depicts the completed repair of the CCO wear package component.

FIGURE 5: RH340 face shovel CCO liner plate repair completed (JCB-Gearvest (Pty) Ltd, 2020)

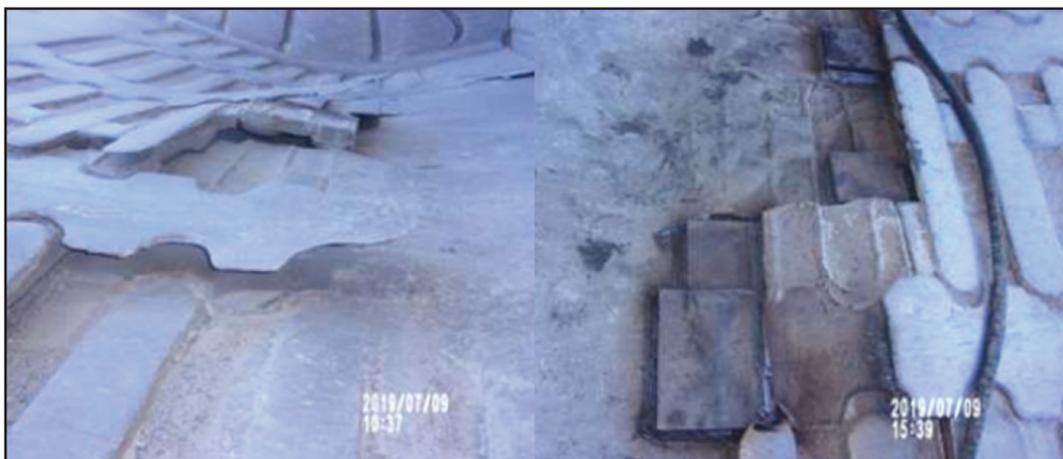
The component relined with standard liner plates sustained significant damage and was temporarily taken out of production due to a breakdown on the front jaw's floor, illustrated in Figure 6. The welding on the remaining vertical liners appeared to have failed, thereby pulling the liners away from the floor section and exposing the floor structure plate to damage and wear.

Had this breakdown not been repaired it would have resulted in the catastrophic failure of the front jaw, resulting in the component being taken out of production and identified for premature repair and relining. The breakdown took approximately five hours to repair, during which the mine lost a potential 7 499.85 tonnes of production, 1 499.97 t/h.

FIGURE 6: Standard wear package damage (LHS), repair (RHS) (JCB-Gearvest (Pty) Ltd, 2019)

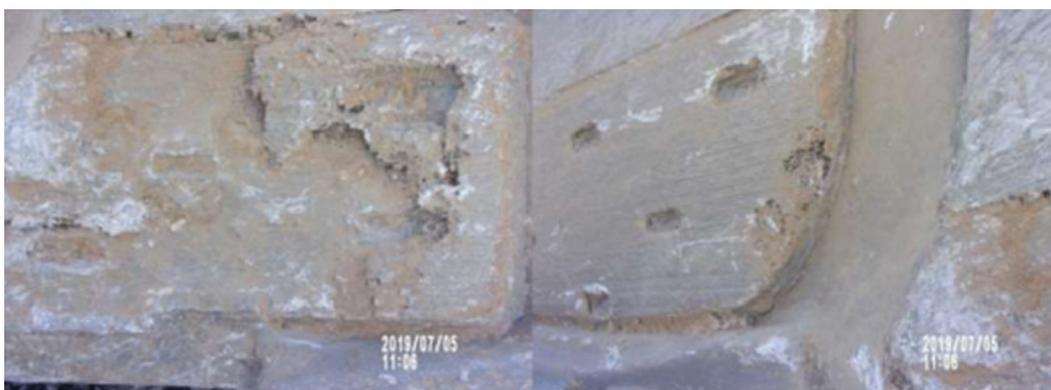
The data analysis of the field service reports shows that the component repaired with CCO liner plates, illustrated in Figure 7, performed progressively worse as the overlay on the composite liner plates started to delaminate and chip; however, they sustained no critical breakdowns.

Initially performing well and showing no signs of excessive wear or having sustained damage due to impact, once the liner plates started to chip, the damage spread at a significant rate to the rest of the composite liner plate part. The observation was only made on composite liner plates placed in medium impact and high-wear zones.

The orientation of the overlay deposit on the the design of the CCO floor plate was perpendicular to the direction of the wear, however, this was not the case with the worse performing sidewall liners. It became evident that the orientation and placement of the CCO wear package must be further improved upon and researched.

**FIGURE 7:** CCO wear package field service evaluation (JCB-Gearvest (Pty) Ltd, 2019)

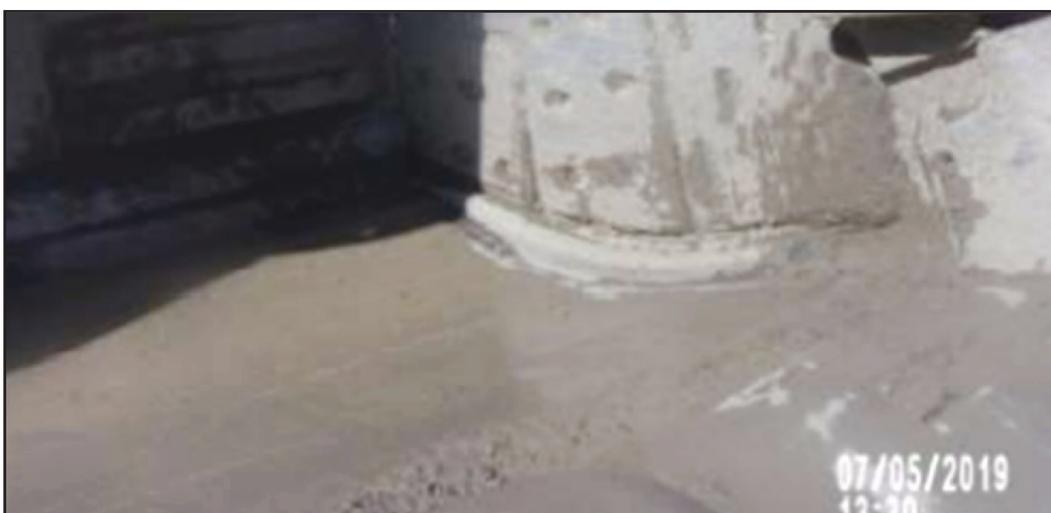
The floor liner plate, illustrated in Figure 8, which is manufactured entirely from composite liner plate, performed remarkably well, showing no signs of damage or significant wear during the field service observations.

**FIGURE 8:** CCO wear package field service evaluation inside floor (JCB-Gearvest (Pty) Ltd, 2019)

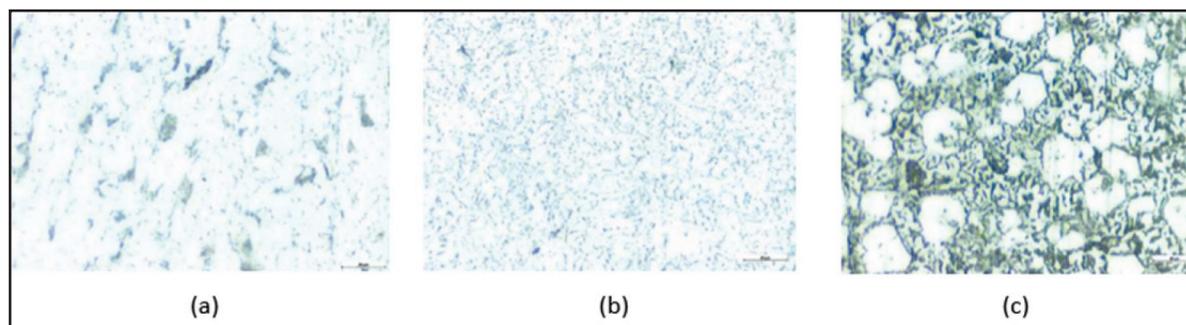
12, indicated that an additional layer was deposited on top of the first layer of overlay.

**FIGURE 12:** CCO sample evaluation: (a) Substrate microstructure of ferrite and pearlite, (b) Intermediate layer microstructure of ferrite and carbides, (c) Overlay microstructure of chunky carbides and pearlite (Carter, 2020).
