# Evaluation of Composite and Standard Liner Plates on Hydraulic Face Shovels Operating in Platinum Mines

The article details the results of research determining whether the use of composite liner plates, specifically chromium-carbide overlay (CCO) liner plates could be recommended as an alternative to abrasion-resistant (AR) plates to extend the production cycle of hydraulic face shovels operating in platinum mines.

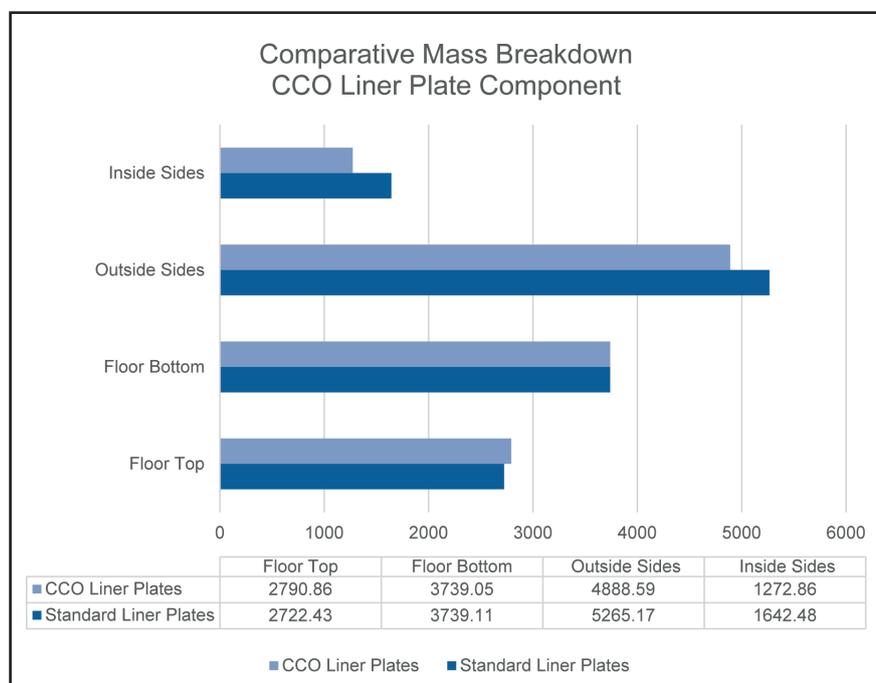
On the same component, the mass of the current combined, CCO liner plates and standard liner plate package design, used to reline the RH340 front jaw composite liner plate component will be 677.83 kg lighter than a component relined with a standard liner plate package as illustrated in Figure 2.

This equates to the front jaw being approximately 5.34% lighter when relined with CCO liner plates but will have little to no effect on the carrying or load capacity of the component. For calculations and analysis purposes the value was simplified to 600 kg saving on mass.

FIGURE 2: Comparative mass breakdown CCO liner plate component (JCB-Gearvest (Pty) Ltd, 2018)

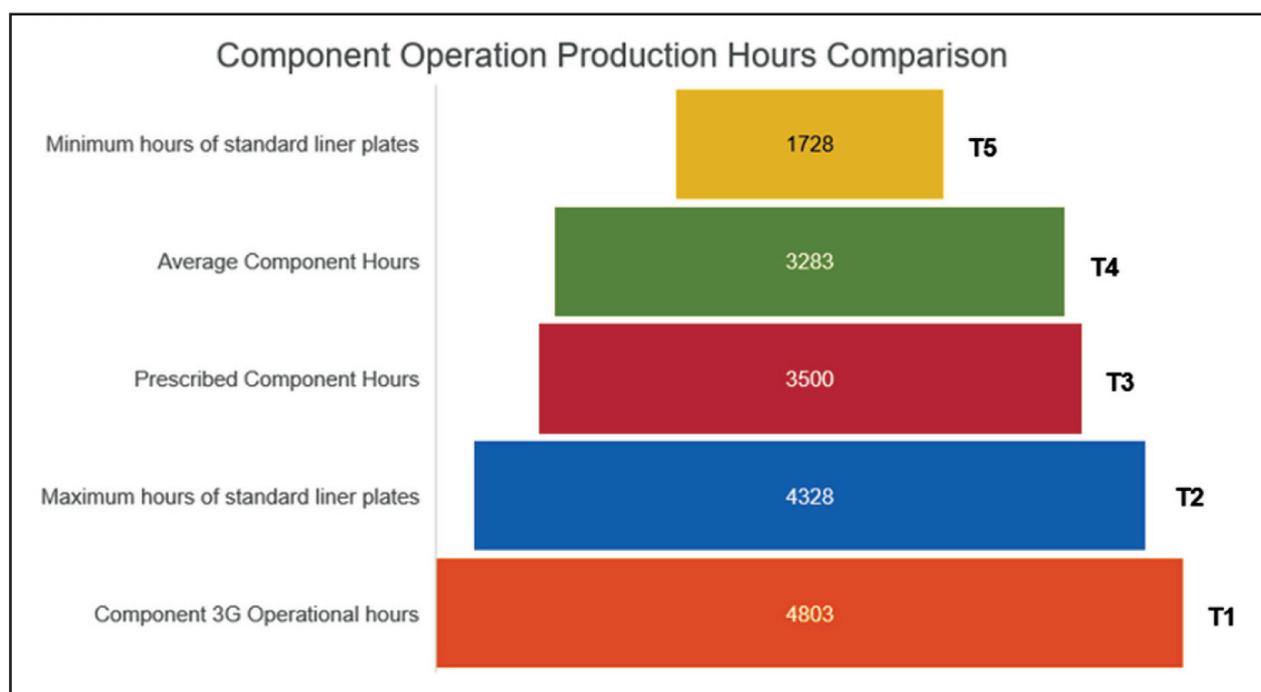
The component with CCO liner plates in the high-wear zones, and certain high-wear, medium impact zones managed 4 803 hours (Figure 9, Orange – T1) in production, which is 37% more than the desired minimum number of hours and 46.30% more than the average RH340 face shovel component.

Borox found that at a minimum an RH340 component repaired with standard liner plates, with wear having been identified as the primary cause for failure, managed only 1 728 hours (Figure 9, Yellow – T5) in production (Borox Wear Parts (Pty) Ltd, 2020). This is approximately 50.62% less than the desired 3 500 hours (Figure 9, Red – T3) in production.

On Average, an RH340 face shovel component repaired using standard liner plates also managed an average of 3 283 hours (Figure 9, Green – T4) and a maximum of 4 328 hours (Figure 9, Blue – T2) in production (Borox Wear Parts (Pty) Ltd, 2020). Approximately 9.37% longer than the desired minimum in production.

FIGURE 9: Component operation production hours comparison (Borox Wear Parts (Pty) Ltd, 2020)

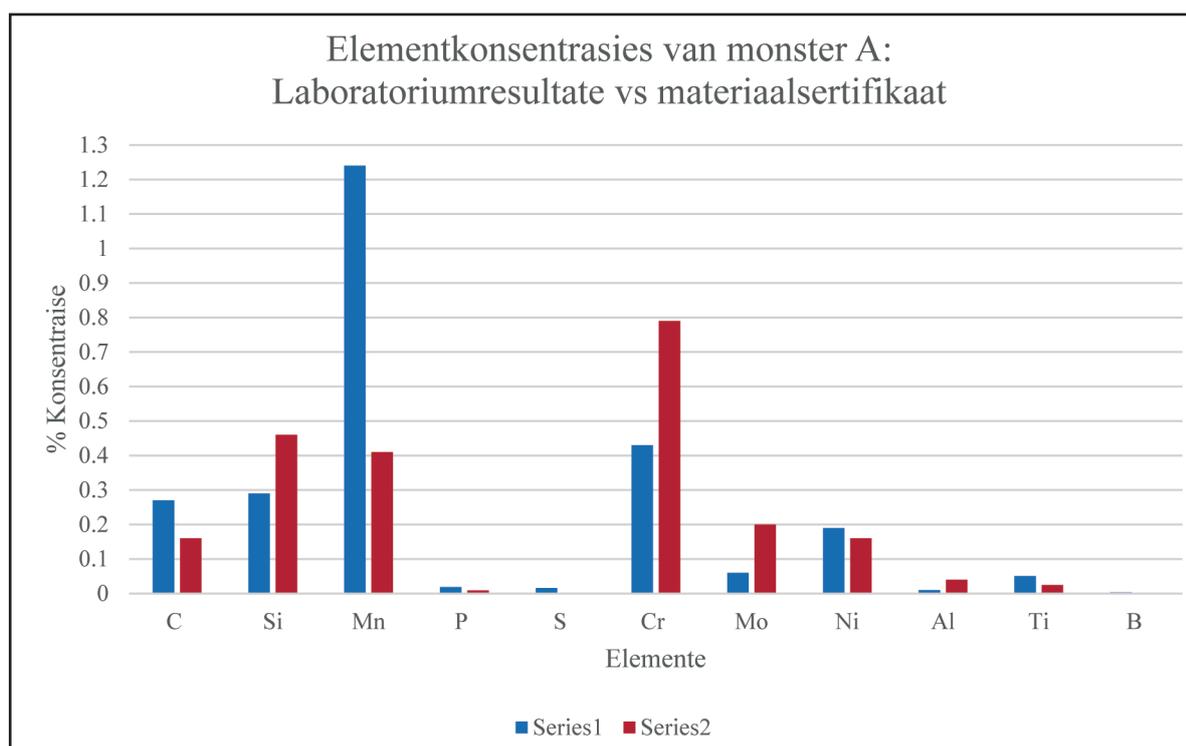
Figure 10 (Sample A) and Figure 11 (Sample B) illustrate the discrepancy between the element concentration specified in the material certificates and element concentration obtained during the laboratory testing.

FIGURE 10: Element concentration comparison of Sample A

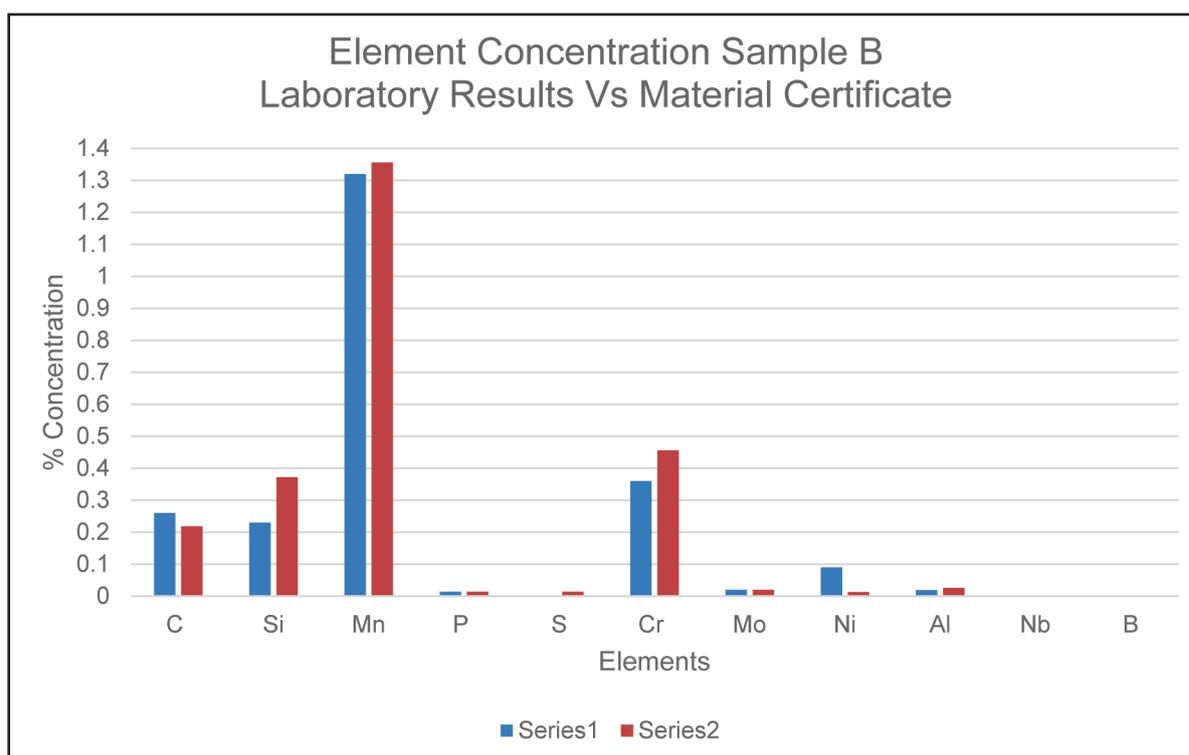
FIGURE 11: Element concentration comparison of Sample B
